## Audit/Twinning Report

Station name: Danum Valley  
Date: November 26 -30 2017  
Auditor: Dr. Thomas Tuch (WMO-GAW-WCCAP, TROPOS)  
Responsible station staff: Maznorizan Bt Mohamad, Mohan Kumar A/L Sammathuria

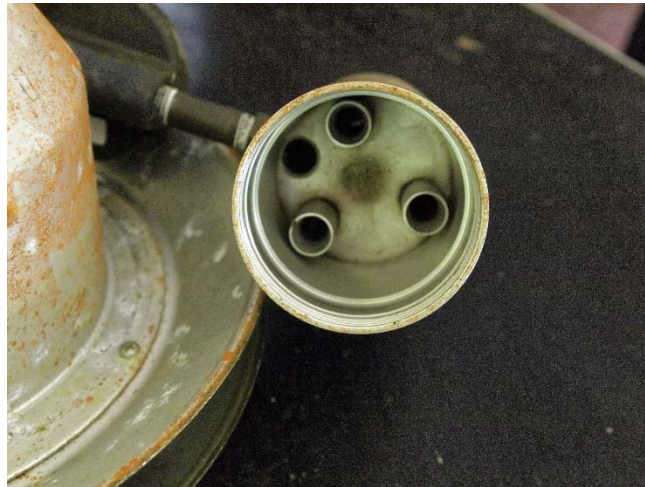
The aerosol inlet at Danum Valley has been designed at TROPOS. It features two custom made Nafion dryers. The PM10 inlet head was found to be relatively clean inside (Figure 2).

Figure 2: PM10 inlet at Danum Valley

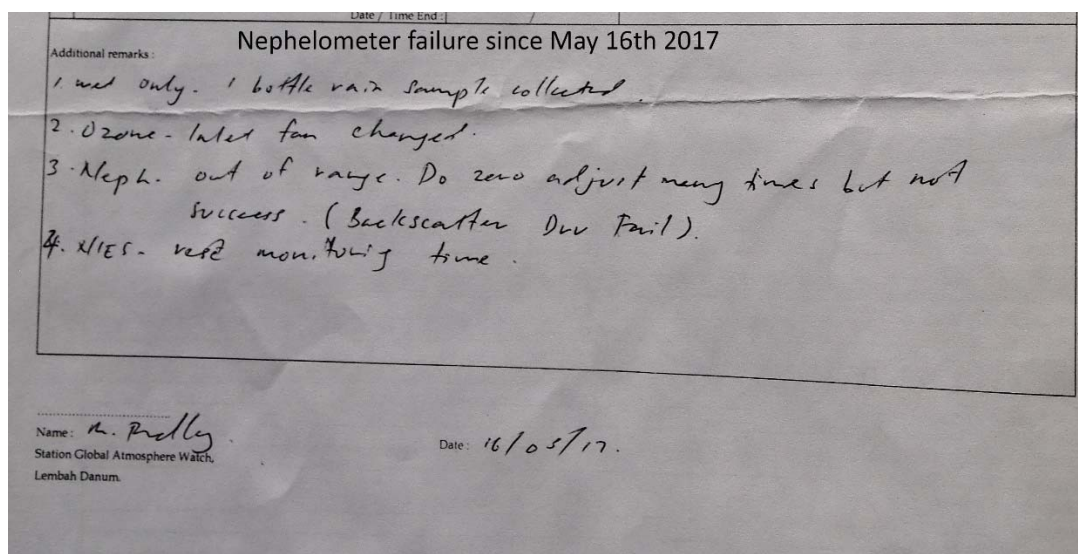
The backscatter shutter of the Nephelometer Ecotech Aurora 3000 (SN 11-1011) did fail on May 16<sup>th</sup> 2017 (Figure 5). As result, the instrument could not be calibrated after this date. Data of the instrument cannot be used after May 16<sup>th</sup>.

Figure 5: Nephelometer failure notice in the logbook.

The instrument was opened to investigate the error. The motor of the backscatter shutter is broken. The light source with the backscatter shutter needs to be send to the manufacturer for repair.

**Nephelometer data are unusable beginning from May 16<sup>th</sup> 2017.**

- 1) The Nephelometer cell should be checked and cleaned (if necessary) on an annual basis.
- 2) The backscatter shutter needs to be repaired by the manufacturer.

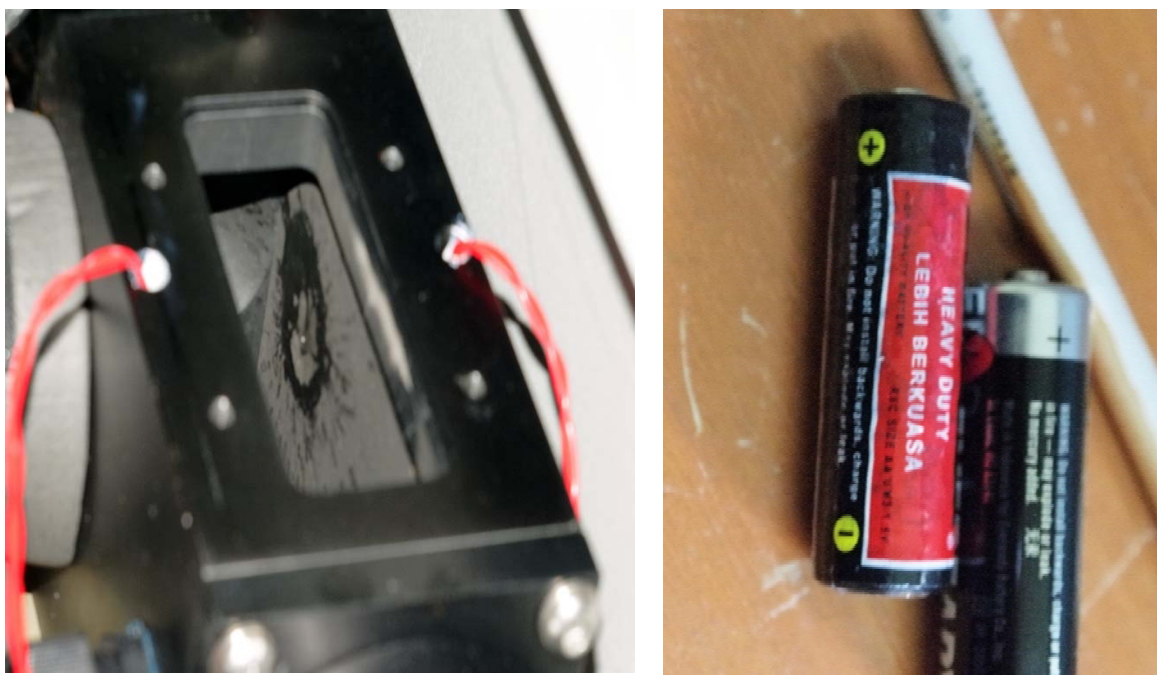
With the instrument open we found the measurement cell heavily polluted. Furthermore the backup batteries have not been replaced for several years. These batteries should be replaced at least once per year to avoid damage to the instrument (Figure 6).

Figure 6: Dirty measurement cell and broken backup batteries of the Nephelometer.

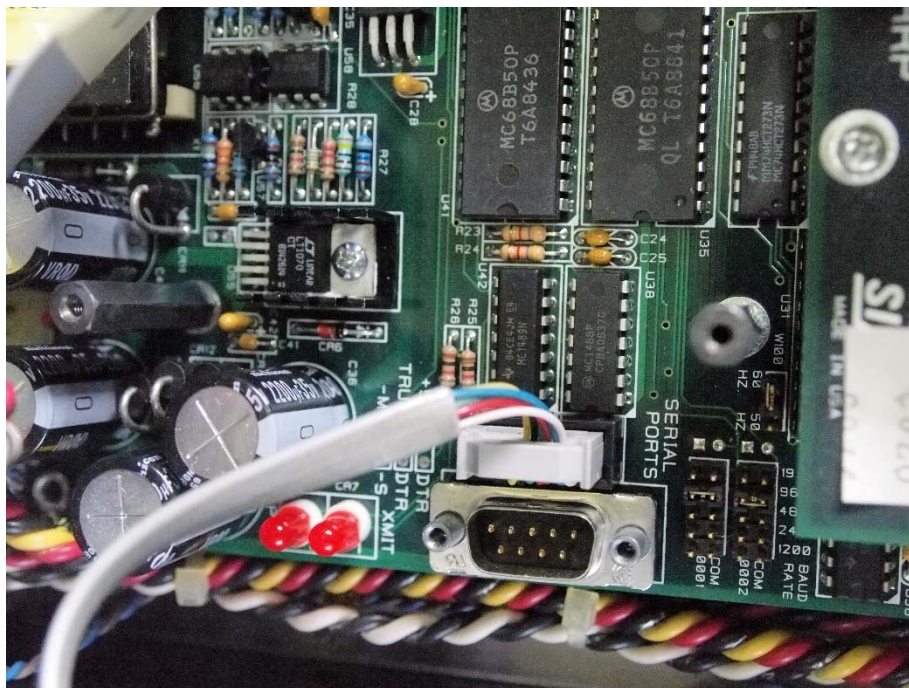
The TEOM SN 140AB214609703 was running upon arrival at the station. Data communication was, however, again not possible due to a problem with the serial port of the instrument. This failure was first observed in July 2017. The motherboard of the TEOM control unit was replaced by an existing spare part during the audit (Figure 8).

Figure 8: TEOM motherboard with internal serial connector.

After change of the motherboard, the instrument was able to communicate via serial port. With this board heating of the TEOM sensor unit did not work. The instrument could therefore not stabilize into measurement mode.

**TEOM data are not available starting July 2017.**

There are spare TEOM control units available at the headquarters in Kuala Lumpur. One of these units should replace the broken control unit at Danum Valley. Note that all operation parameters need to be transferred from the broken instrument to the replacement unit.

**Recommendation: The broken control unit should be replaced by a spare control from Kuala Lumpur.**
